Dealing with *Flash Rust*

by John Tanner, Manager of Government Services,
Ameron Performance Coatings and Finishes, Baltimore, MD

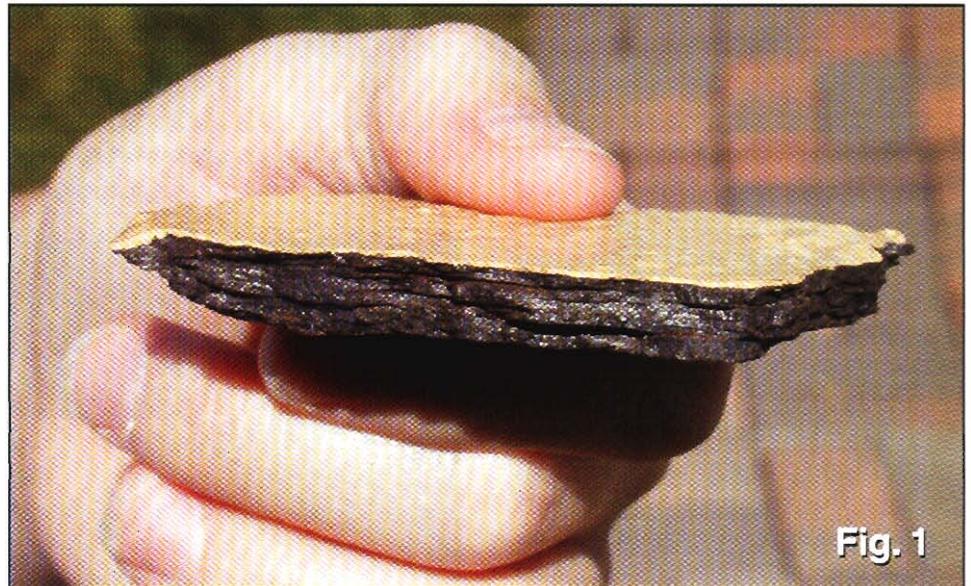
Fig. 1

(See Fig 1.) I explained that the major cause of failure when coating over supposedly "tight rust" was going over rust scale, which is rust that forms

in layers as the steel breaks down. The coating adheres to the scale, but when the scale falls off, so does the coating!

This was probably what happened in his forepeak tank. He admitted that there was rust on the backside of the coatings that came off. We didn't have to contend with this possibility on this job because we had written a good specification, which called for the removal of all rust scale. I pointed out that what he was seeing was flash rusting or what some people term "rust back." It can be coated with every expectation of success.
