## Remote Waterjetting Offers Inconspicuous Coatings Removal on LNG Tank

by Lydia Frenzel, Ph.D., Advisory Council, San Marcos, Texas

From June through December of 2001, a large regional distributor of natural gas on the East Coast, a contractor, and a coatings manufacturer teamed together to strip and repaint the exterior of a 14,000,000-gallon (53,200,000-liter) Liquefied Natural Gas (LNG) double-walled tank. The tank stands 125 ft (38 m) tall and has a diameter of 180 ft (55 m).

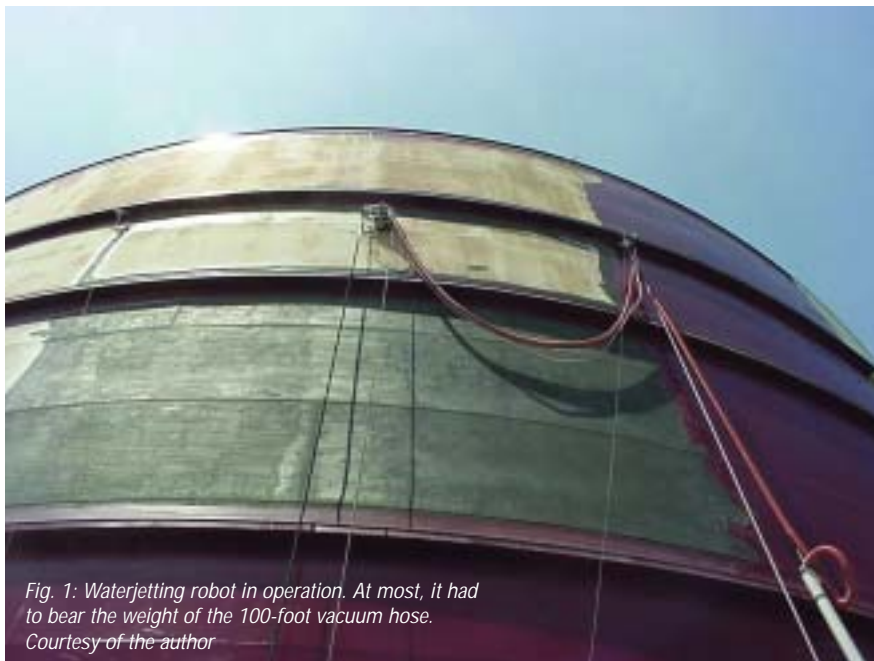
Fig. 1: Waterjetting robot in operation. At most, it had to bear the weight of the 100-foot vacuum hose.  
Courtesy of the author

One of the biggest issues was how to support the weight of the hose at the 120-foot (36-meter) height. The problem took approximately one week to figure out. In the end, the vacuum hose and waterjetting hose were winched up to the band and hung on the band so that the hose weight was minimized for the crawler. The contractor rigged a rigid, 6-inch (15-centimeter) plastic pipe going up the vertical side of the tank as a permanent fixture for the attachment of the flexible vacuum hose that went to the crawler. At most, the crawler had to bear the weight of 100 ft (30 m) of the 4-inch (10-centimeter) flexible vacuum

line (Fig. 1).

At the end of each day, the crew would solvent wipe any areas of flash rusting and apply a primer. Only a little flash rust would form in the region of manual blasting. The affected area was minimal, and flash rust was never considered a problem. Figure 1 shows the priming of the bands and the use of the crawler between the bands.

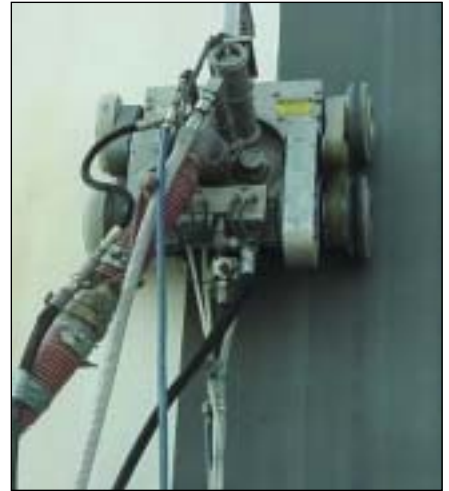
*Fig. 2: Absence of water from the crawler as it worked vertically  
Figs. 2-4 courtesy of NLB Corporation*

The remote crawler tackled most of the surface. The crawler was operated with a vacuum attachment for control of airborne particulates and water. Full-scale containment was not needed. Figure 2 shows the absence of water from the crawler. Typically on the interfering areas, one manual lance, equipped with a five-jet nozzle, was used per pump. The production rate varied from 56 to 108 sq ft (5 to 10 sq m) per hour on the lance.

The bands and stiffeners limited the work area and divided it into sections. Starting at the top of the tank and working down, the crawler would work vertically between the bands while workers performed manual waterjetting (Figs. 2 and 3). Then the

As paint was removed, all surface defects could be observed, including the blast pattern of the original blasting (Fig. 2).

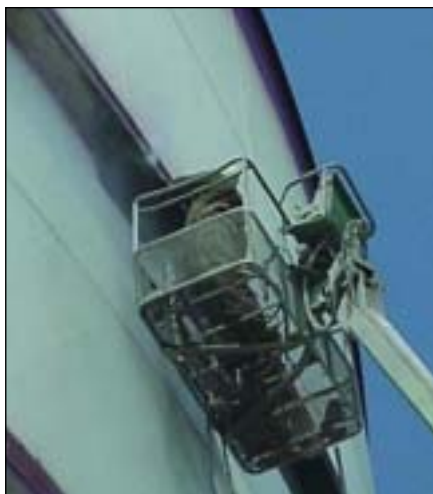
Fig. 3: Manual blasting was used 2 feet above and below the band.

each other. They manually blasted about 2 feet above the band and 2 feet below the band (Fig. 3).

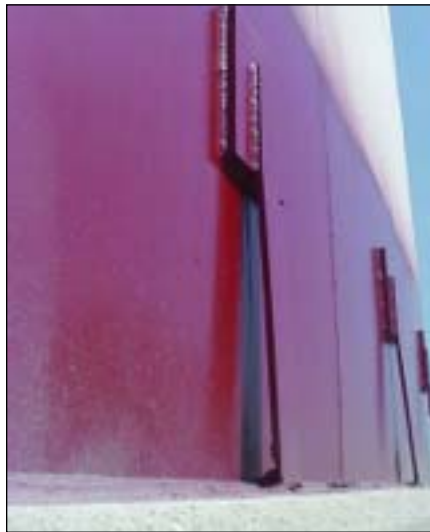
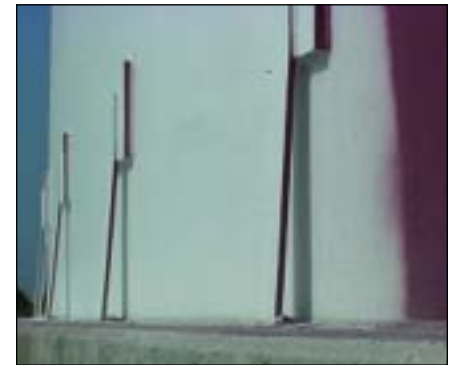
Fig. 4: Bottom straps of tanks primed (left) and topcoated (right)

A series of bottom straps from the tank to the concrete foundation pad was located about 4–5 ft (1.2–1.5 m) apart on the circumference. The straps

are approximately 2 in. (5 cm) wide by 2 ft (0.6 m) tall welded to a plate at the top. The opening behind the strap was 1.5 in. (3.75 cm) at the bottom. Total removal of existing coatings was required. This was accomplished using a nozzle designed for cleaning tubes and a threaded barrel adapted to a rotating lance. Figure 4

illustrates the bottom straps, primed and finished.
